Contract #: 04-0120F4Cty: SF/ALA Rte: 80 PM: 13.2/13.9File #: 1.28**WELDING INSPECTION REPORT****Resident Engineer:** Casey, William**Address:** 333 Burma Road**City:** Oakland, CA 94607**Report No:** WIR-028328**Date Inspected:** 31-Aug-2012**Project Name:** SAS Superstructure**OSM Arrival Time:** 700**Prime Contractor:** American Bridge/Fluor Enterprises, a JV**OSM Departure Time:** 1130**Contractor:** American Bridge/Fluor Enterprises, a JV**Location:** jobsite**CWI Name:** Scott Kortum**CWI Present:** Yes No**Inspected CWI report:** Yes No N/A**Rod Oven in Use:** Yes No N/A**Electrode to specification:** Yes No N/A**Weld Procedures Followed:** Yes No N/A**Qualified Welders:** Yes No N/A**Verified Joint Fit-up:** Yes No N/A**Approved Drawings:** Yes No N/A**Approved WPS:** Yes No N/A**Delayed / Cancelled:** Yes No N/A**Bridge No:** 34-0006**Component:** OBG**Summary of Items Observed:**

Weld Repairs 13W-PP122-W2.8 Y location 300mm

13W-PP121.25-W3 Lifting Bracket removal and grinding

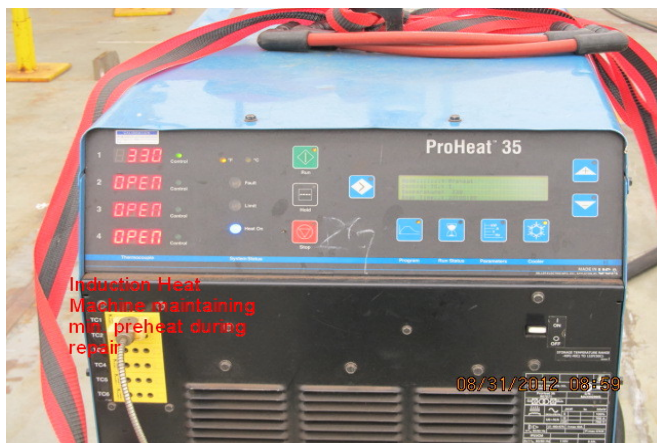
The QA inspector observed first time repairs being performed by ABF welding personnel Lin E Yu (9344) on Deck Splice Weld 12W-W2.8, at the following location:

Y=300 mm, D=2mm, W=40mm, L=20mm

This QA Inspector observed Mr. Yu preheating to a QC recorded, QA verified temperature of 250F prior to using the Carbon Arc Gouging process to remove defects at the above-mentioned locations on the Deck Splice Weld. The locations and depth of the defects had been marked on the steel by the Ultrasonic Technician at the conclusion of his testing. At the end of gouging operations Mr. Yu ground the excavations to a bright clean metal condition in

Prior to welding Quality Control Technician Scott Kortum performed Visual and Magnetic Particle Testing on the above excavations. This Quality Assurance Inspector verified the results of the test by doing duplicate testing to the excavations. No indications were noted.

The welder spent the shortened shift depositing the root passes and fill passes with approximately 100% being completed at the end of the shift. QC inspector Kortum was noted to be present in order to monitor the progress and ensure the welding was within the established Welding Procedure Specification (WPS) noted as ABF-WPS-D15-1004R and supporting Procedure Qualification Records (PQR). Prior to initiating the welding at this location the QC inspector observed the preheat temperature and post heat temperature using a Raytek non-contact Thermometer, was sufficient and compliant to the above-mentioned WPS. Using a Tempil Stick, (temperature indicating crayon) the preheat, and post heat temperature was then verified by this QA inspector to be greater than 350F and 450F respectively. The parameters, using a Fluke brand Tong style meter, was verified to be 139 amps.

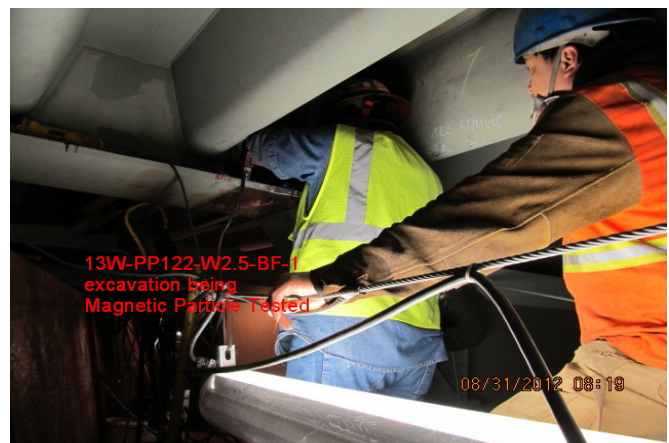
13W-PP121.25-W3 Lifting Bracket being removal and grinding

This QAI observed the grinding at a 3:1 ratio of the above-mentioned remains of 13W-PP121.25-W3 Lifting Lug Bracket. The remains are being ground or faired to a 3:1 slope to accommodate design criteria. The personnel involved are using 8" angle grinders to achieve the above mention requirements. At the conclusion of grinding the area is tested using Magnetic Particle Testing and Visual Testing to check for any base metal or weld metal fracturing. No areas were ready for inspection or testing on this day.
